Falkland Conservation Area Appraisal and Management Plan

April 2010

This report was written by Arc on behalf of Fife Council. It reflects the view of Fife Council and does not necessarily represent the opinions of Arc.

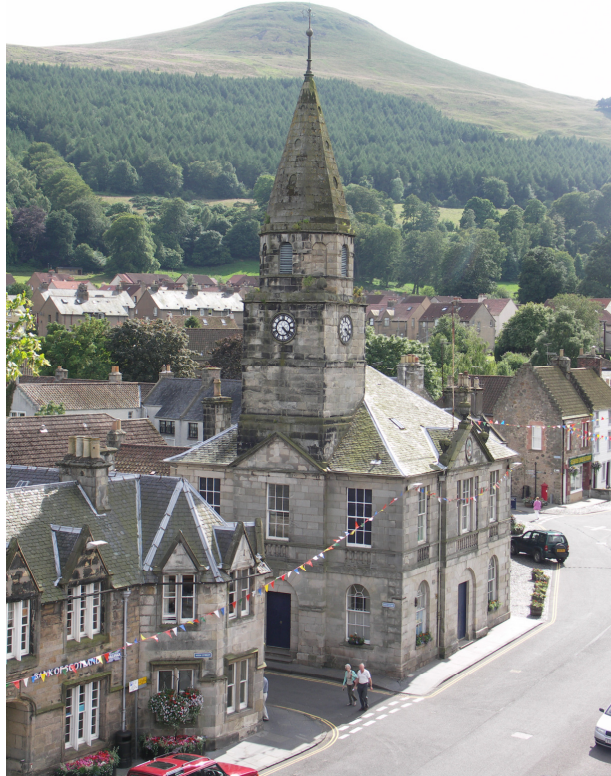
The Town House design subtly balances civic presence with continuity of street façade height.

The subtle front elevation elegantly marries the civic importance of the height of its clock tower with the 2-storey buildings either side, giving a graceful and undemonstrative street presence typical of other Georgian alterations to the burgh.

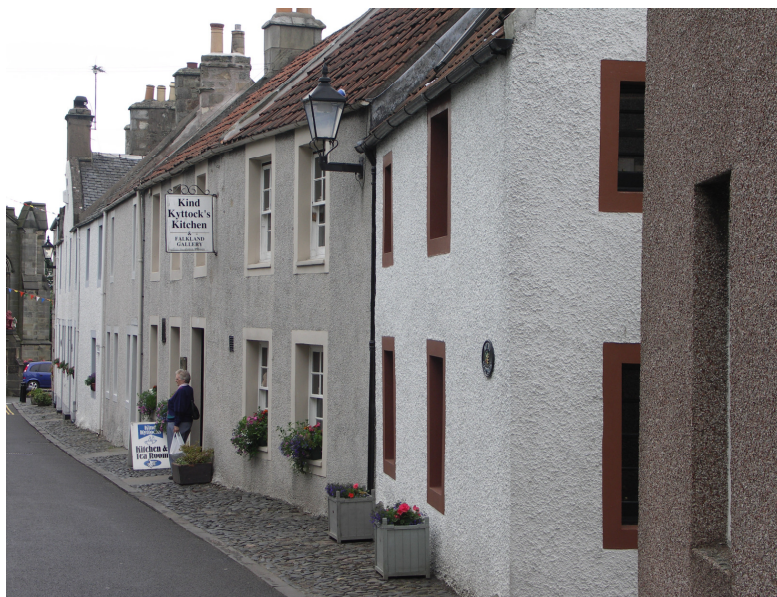
The continuous street façade is a key characteristic of the area

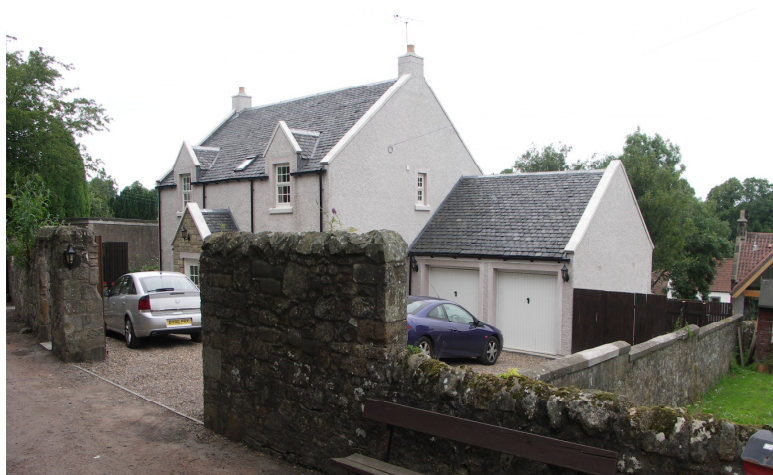
Modern backland development replaces the historic burgh boundary wall and rigg garden with development that is suburban in character.

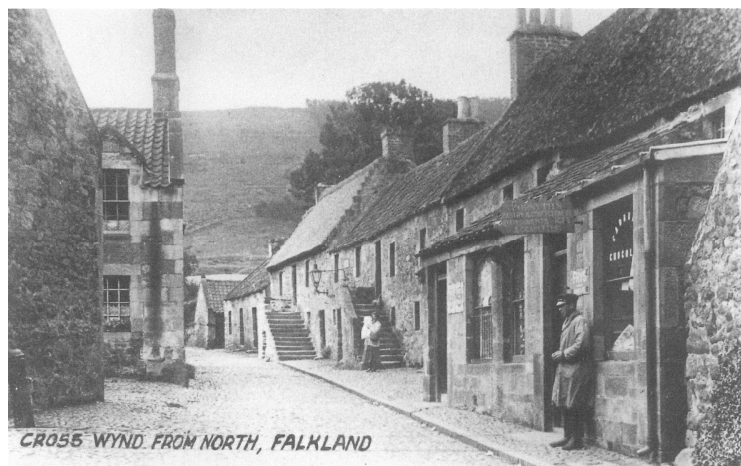
Cross Wynd in the early 20th century, a dense urban area showing many of the characteristic features of the historic Falkland townscape

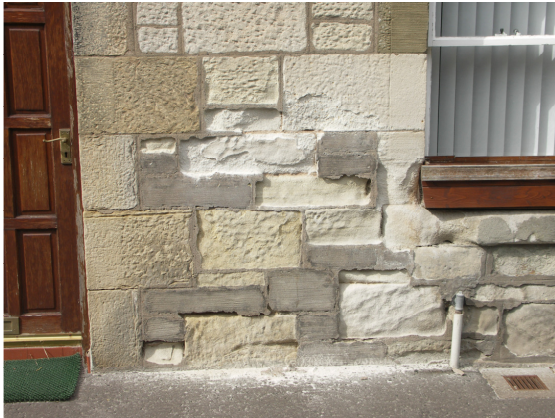
Mortar repairs in cement will damage sandstone masonry

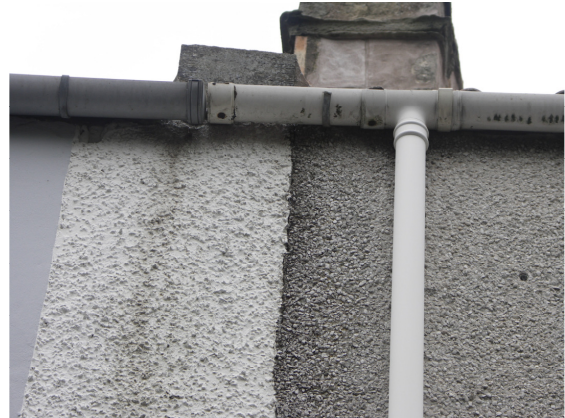
Cement renders and plastic gutters are never appropriate.

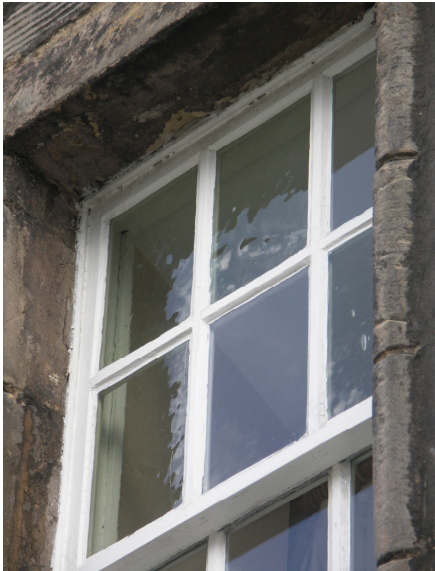
Modern plate glass does not match the original crown glass, while the white gloss paint is inappropriate.

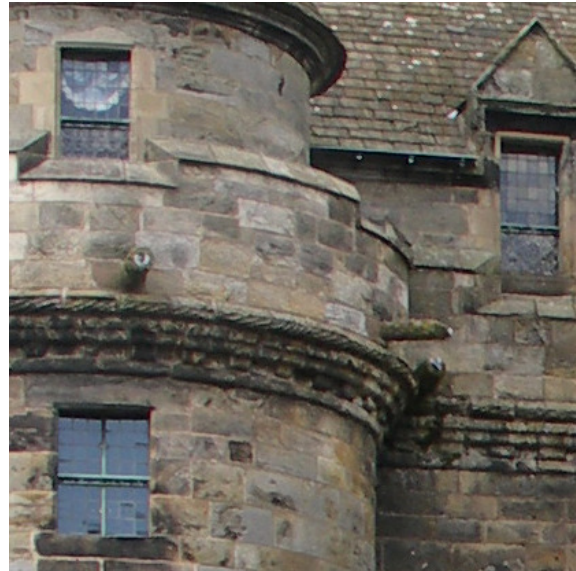
Coloured timber windows are historically appropriate.

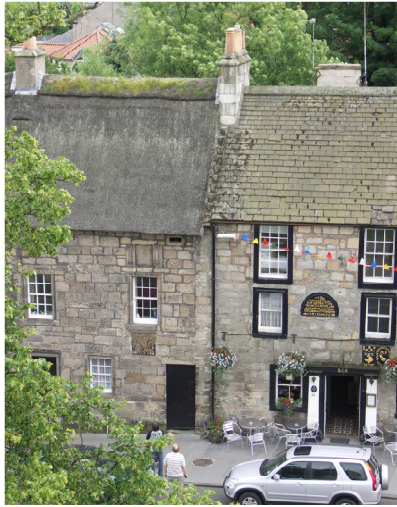
Traditional thatch and slated roofs

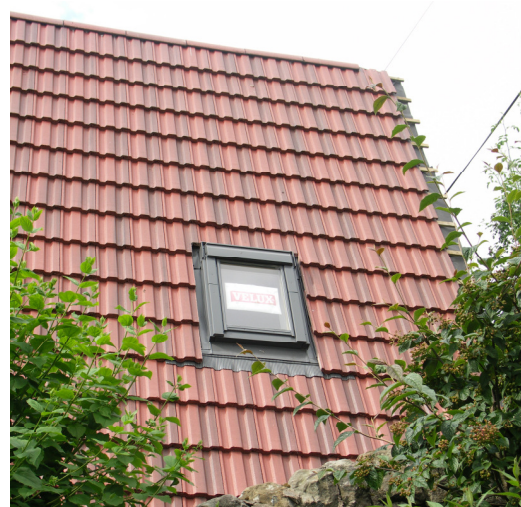
Synthetic tiles and modern rooflights are never appropriate.

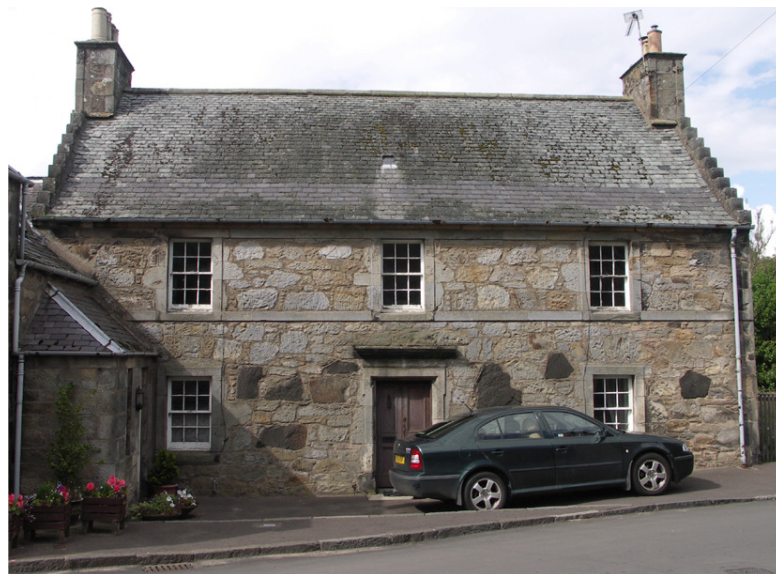
Mixing slate types during repairs should be avoided.

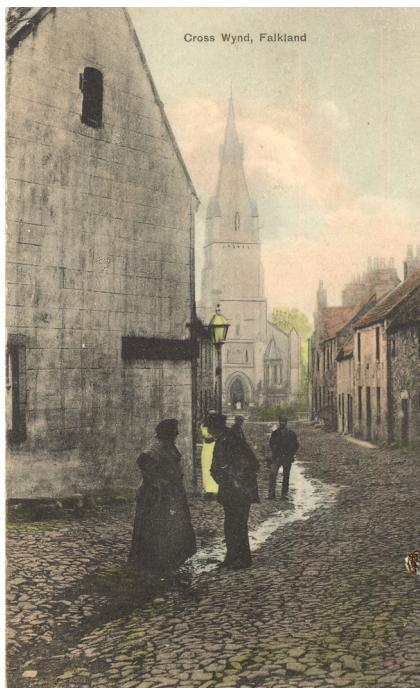
Cross Wynd showing surface drainage over cobbles.

In medieval times the streets would have been mainly unpaved, by the late 19th century most of the road surfaces were covered over completely between the buildings with whinstone setts and cobbles. Prior to the introduction of underground drainage and water supplies, streets such as Cross Wynd had burns running down the centre of the street.

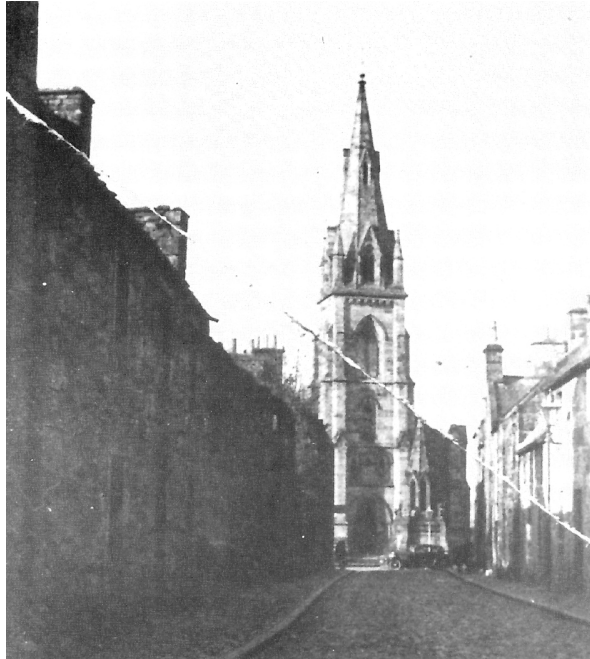
Cross Wynd showing later pavements and street with stone setts and underground drains.

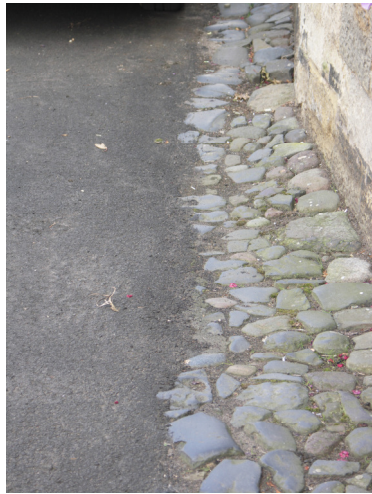
Tarmacadam lacks the scale and local character of the cobbles it covers.

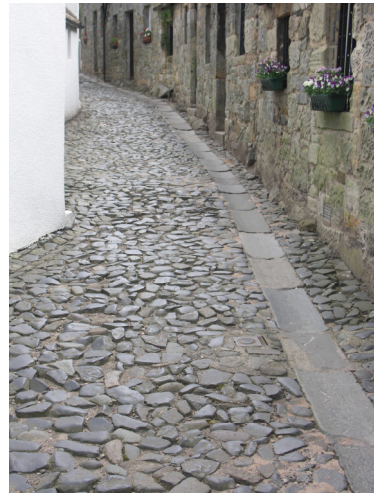
If well maintained, the surviving cobbles surfaces are a significant aspect of the townscape.

The small random nature of the whinstone cobbles suggest they were a secondary product created by the production of larger stones, such as kerbs and setts, from the basalt whinstone quarries that sprung up on the Lomond and Ochil hillsides during the 19th century. Alterations and maintenance in the 20th century introduced a variety of other materials including stone and concrete slabs and tar macadam. The cobbles areas of Falkland are still sufficiently extensive to constitute a major aspect of the town's character and consequently require conservation. Some areas of pavement, including some old cobbled areas, are in a poor state of repair and these are often located in areas of uncertain ownership.

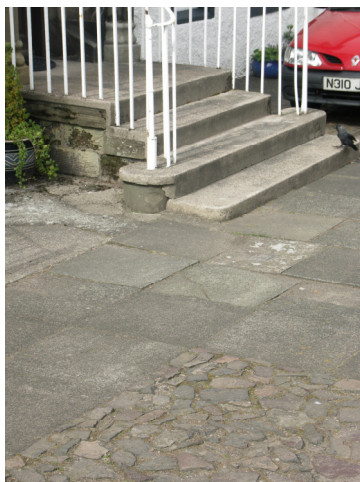
Cement re-surfacing of stone steps erodes townscape character

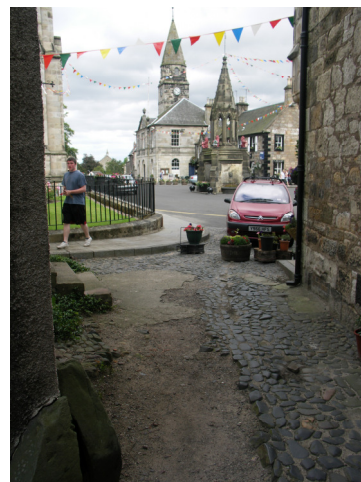
An old cobbled pavement in poor state of repair

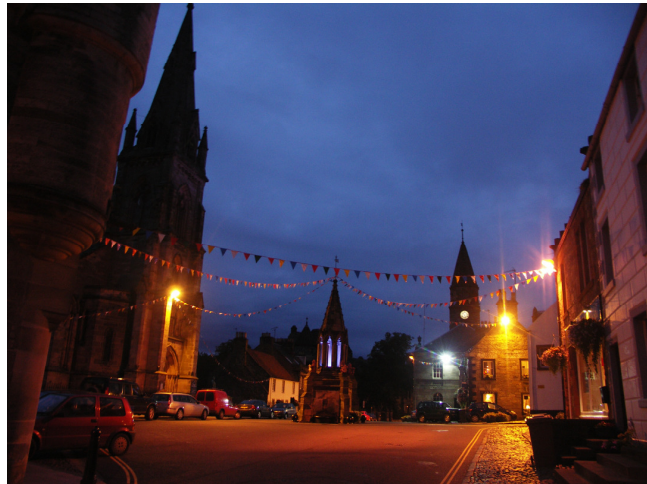
Utilitarian lighting of the pedestrian and car surfaces fails to present the richness of the architectural heritage of the area

The variety of street light fittings brings confusion rather than richness to the presentation and appearance of the public spaces. The quality of light, both in colour and how it models the streets and buildings at night fails to present the area's subtle complexity.
